Site Information

Quadrelliot carried out a drone-based visual inspection of the roof at Basildon Park, Lower Basildon, Reading RG8 9NR on 2026-07-16 using a DJI Air 3S. Weather conditions at the time of inspection were clear / sunny. The roof was recorded as being in good condition overall. 4 defects were identified during this inspection: 2 moderate, 2 minor. The moderate item or items should be reviewed within the recommended timeframe to reduce the risk of further deterioration.

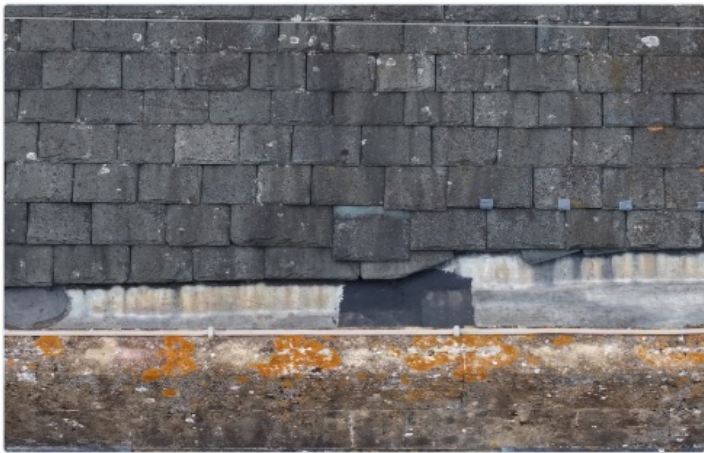
D01-A — Slipped Tiles / Slates, Perimeter / Edge

D01 — Slipped Tiles / Slates

**Location** Perimeter / Edge  
**Severity** Minor  
**Recommended Action** Schedule repair within 3–6 months

Slipped tiles or slates were observed at Perimeter / Edge. This may expose the roof covering and increase the risk of localised water ingress if left unresolved. Repair or repositioning by a suitable roofing contractor is recommended. This item should be addressed as part of routine maintenance or when next practical.

**Notes:** One slate within the lower courses is visibly displaced below the line of the adjacent slates. The slate should be checked and securely refixed before further movement occurs.

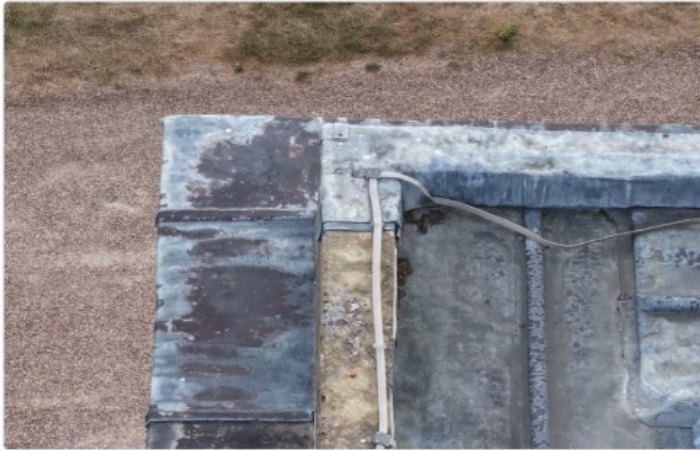
D02-A — Blocked Gutters / Outlets, Gutter Line

## D02 — Blocked Gutters / Outlets

Blocked gutters or outlets were observed at Gutter Line. Restricted drainage may lead to overflow, staining, dampness or localised water ingress. The rainwater goods should be cleared and checked for correct flow. This item should be addressed as part of routine maintenance or when next practical.

**Notes:** A localised accumulation of organic debris is visible within the corner of the lead-lined gutter. The drainage route remains largely open, but the debris should be removed to prevent further accumulation and possible restriction of rainwater flow.

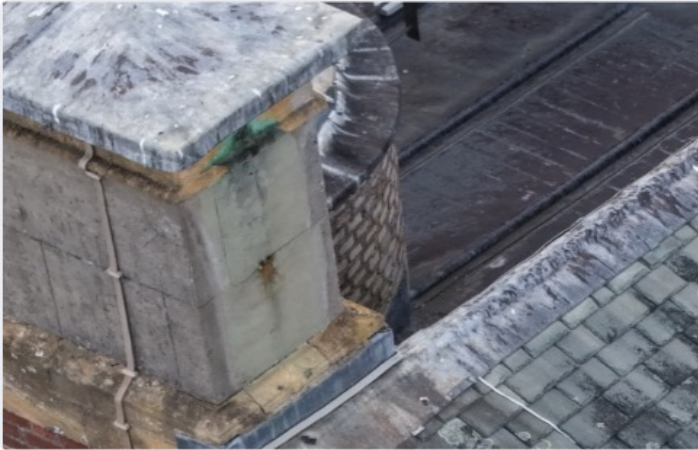
D03-A — Chimney / Stack Deterioration, Around Chimney / Stack

### D03 — Chimney / Stack Deterioration

**Severity** Moderate

A chimney / stack deterioration was observed at Around Chimney / Stack. The affected area should be reviewed by a suitable contractor to determine the cause and appropriate remedial action. Repair or contractor review is recommended within the stated timeframe to reduce the risk of further deterioration.

**Notes:** Localised deterioration is visible beneath the stack capping at the upper corner, with underlying material exposed. The area should be inspected at close range and repaired as necessary to restore a secure, weather-tight finish.

**Recommended Action** Further investigation by roofing contractor recommended

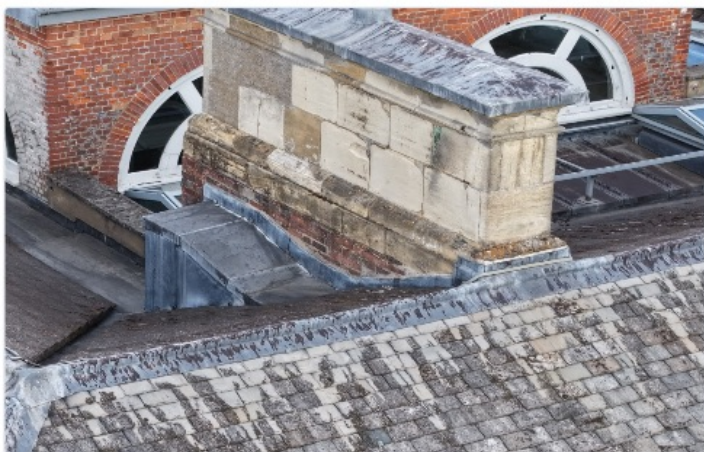
D04-A — Chimney / Stack Deterioration, Around Chimney / Stack

## D04 — Chimney / Stack Deterioration

| Severity | Moderate |

A chimney / stack deterioration was observed at Around Chimney / Stack. The affected area should be reviewed by a suitable contractor to determine the cause and appropriate remedial action. Repair or contractor review is recommended within the stated timeframe to reduce the risk of further deterioration.

**Notes:** Weathering and localised deterioration are visible to the masonry and mortar joints around the stack, particularly along the projecting stone courses above the brickwork. A close-range inspection is recommended to identify any loose material and determine the extent of repointing or masonry repairs required.

| Recommended Action | Further investigation by roofing contractor recommended |
